317 GATEWOOD DR., MOUNTAIN GROVE, VA
BUILDING STRUCTURAL ASSESSMENT

REPORT ISSUE DATE: 02.02.2021
PROJECT NAME: 317 GATEWOOD DR.
S&A PROJECT ID: 21-014
SITE VISIT: 01.29.2021

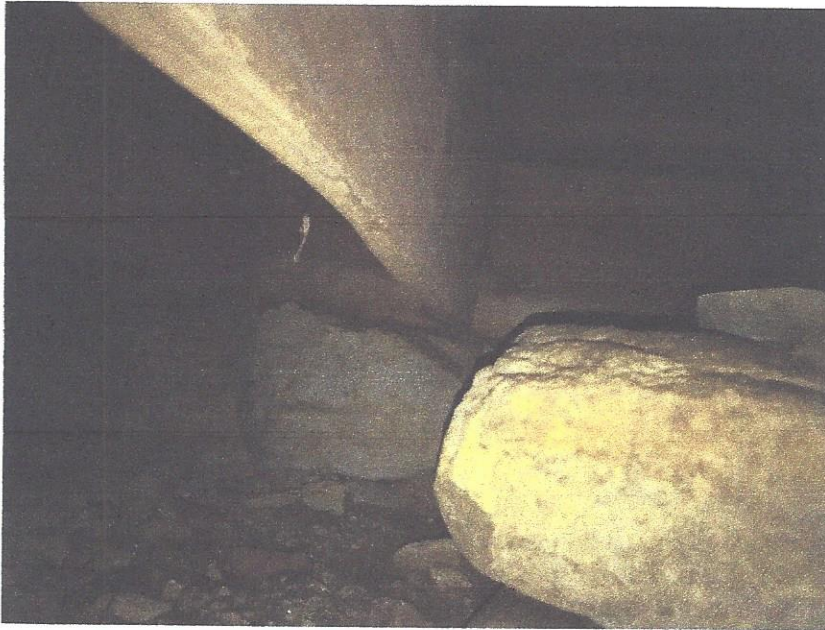
Stone Masonry Foundation + Visible Wood Floor Framing

The primary foundation for the Main House consists of stone masonry. Generally, the foundation appears to be in overall good condition and does not appear to be in need of immediate repairs. At various locations, masonry repointing efforts have been completed.

The in place wood floor framing that was visible during the time of the site visit appears to be in generally good condition. At one location, evidence of previous insect infestation damage is present. In light of this, we recommend pest control treatment as soon as possible, as to avoid additional decay.

Rainwater runoff appears to be expelling under the foundation skirt/perimeter wall and likely continues into the crawlspace during rain events. In light of this, we recommend that the rainwater runoff be redirected as needed to eliminate rainwater intrusion into the crawlspace.

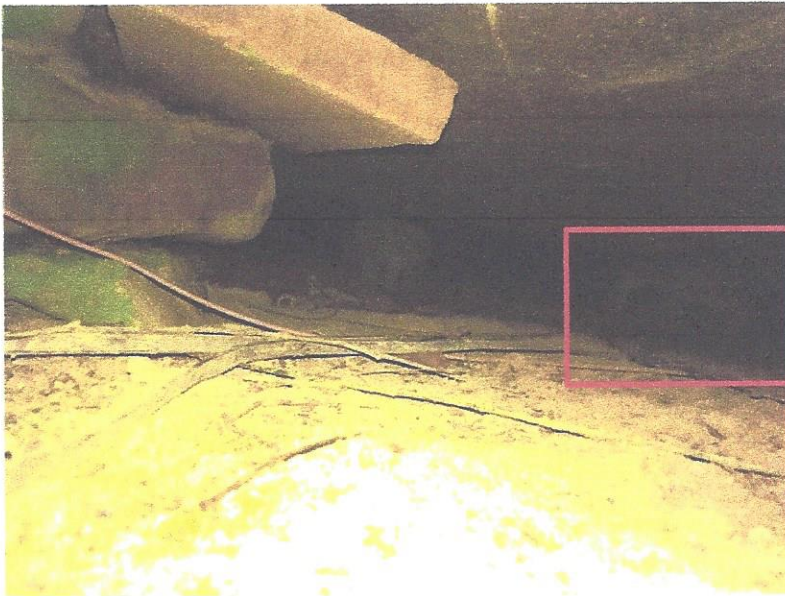
Interior Brick/CMU Piers

At one location within the crawlspace, a single CMU pier is present. The pier at this location is likely in need of reinforcement. However, this is a relatively minor repair that your brick/stone mason can rebuild without additional guidance from our firm. However, when you get to this, please feel free to contact me, and I will be happy to provide a specification for this pier reinforcement.
